June 28, 2019
File No. 262018.063

Subject: Department of Natural Resources Washington Geological Survey,
School Seismic Safety Assessment Project, Contract No. AE 410 -
Seismic Evaluation for **Fife School District**

School Buildings Evaluated in the Fife School District

1.1 Building Description

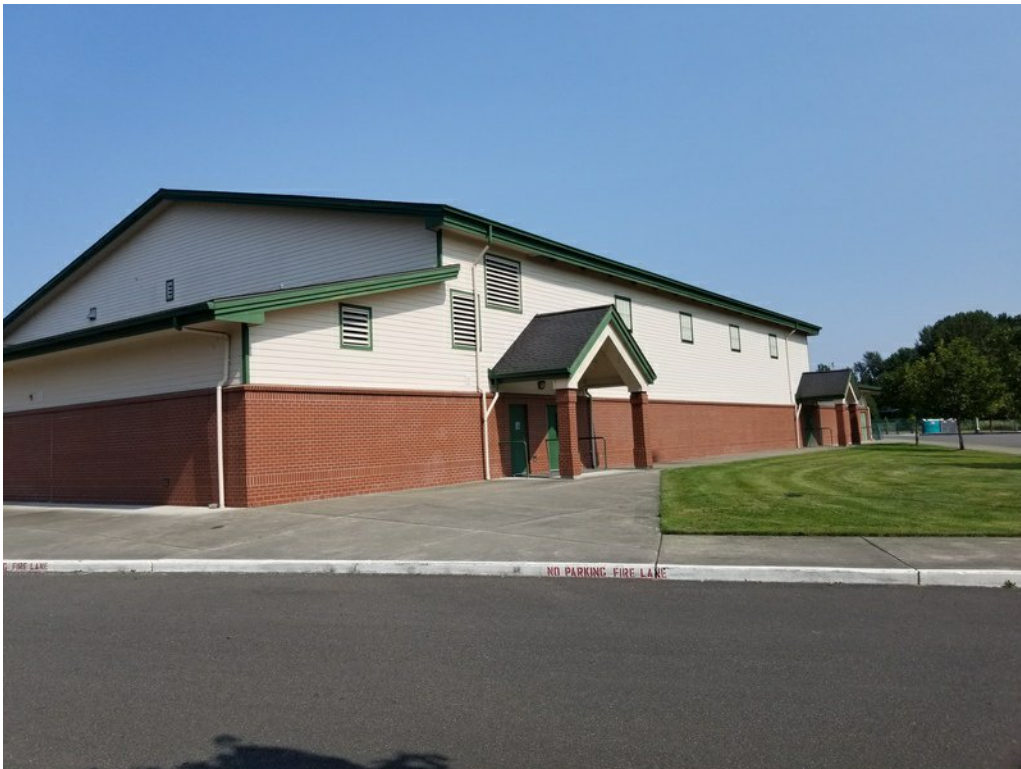
Figure 1-2. Exterior west entrance to gym area.

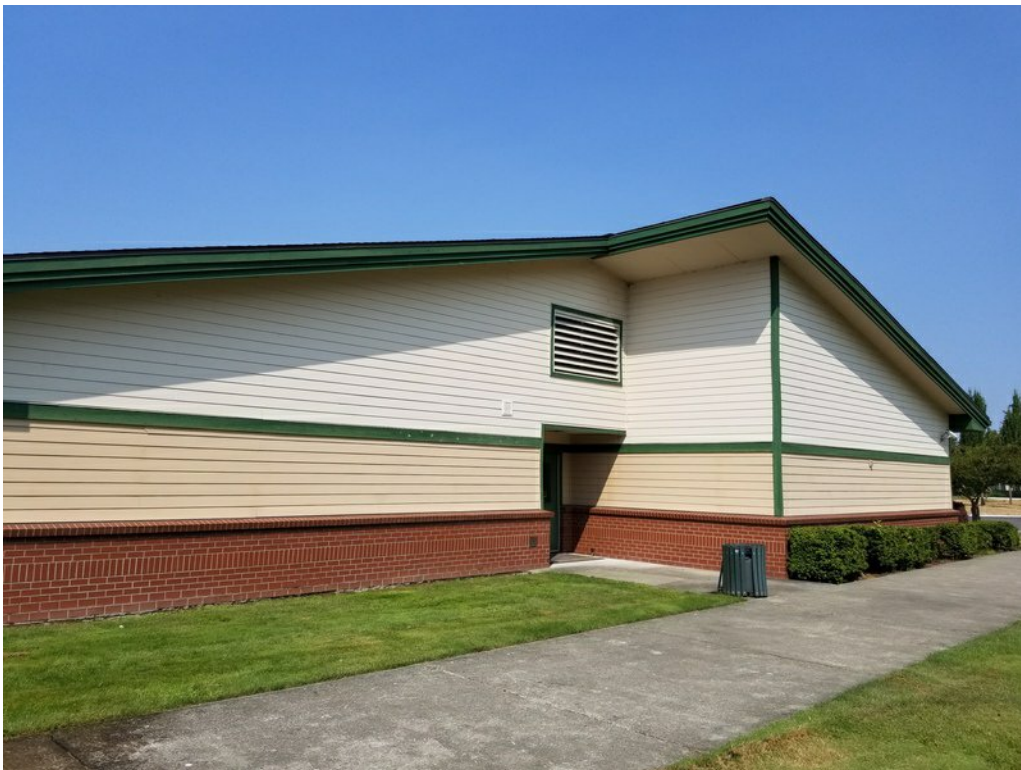
Figure 1-4. Exterior south-central side of building.

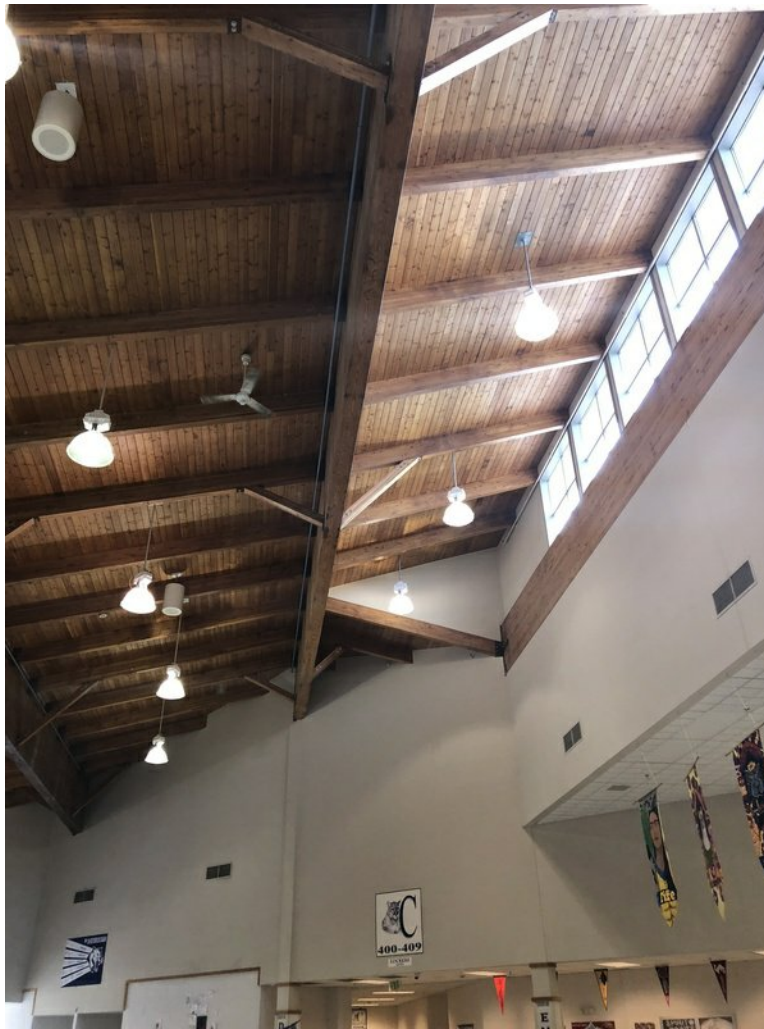
Figure 1-5. Building main entrance interior.

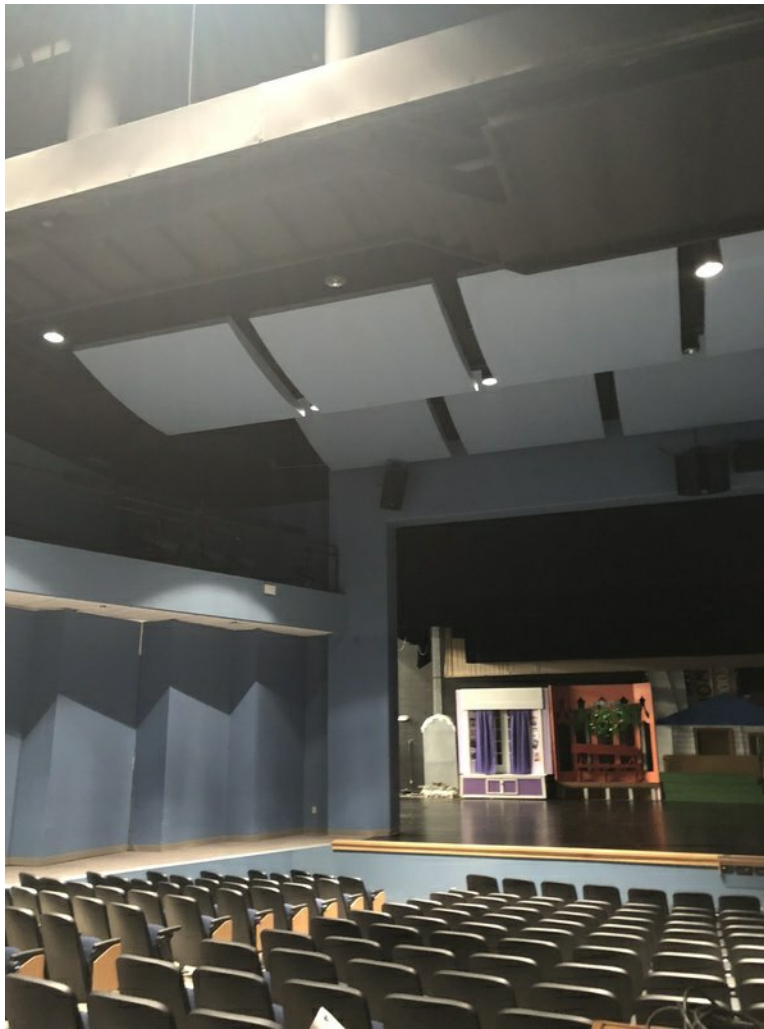
Figure 1-6. Theater interior.

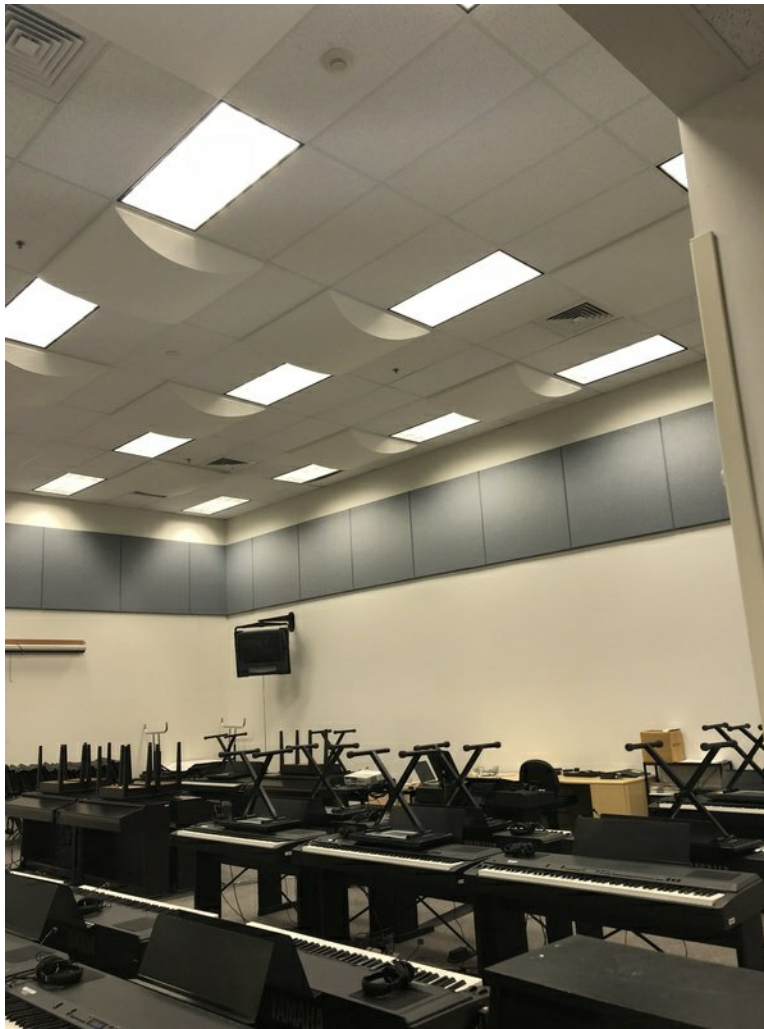
Figure 1-7. Classroom interior.

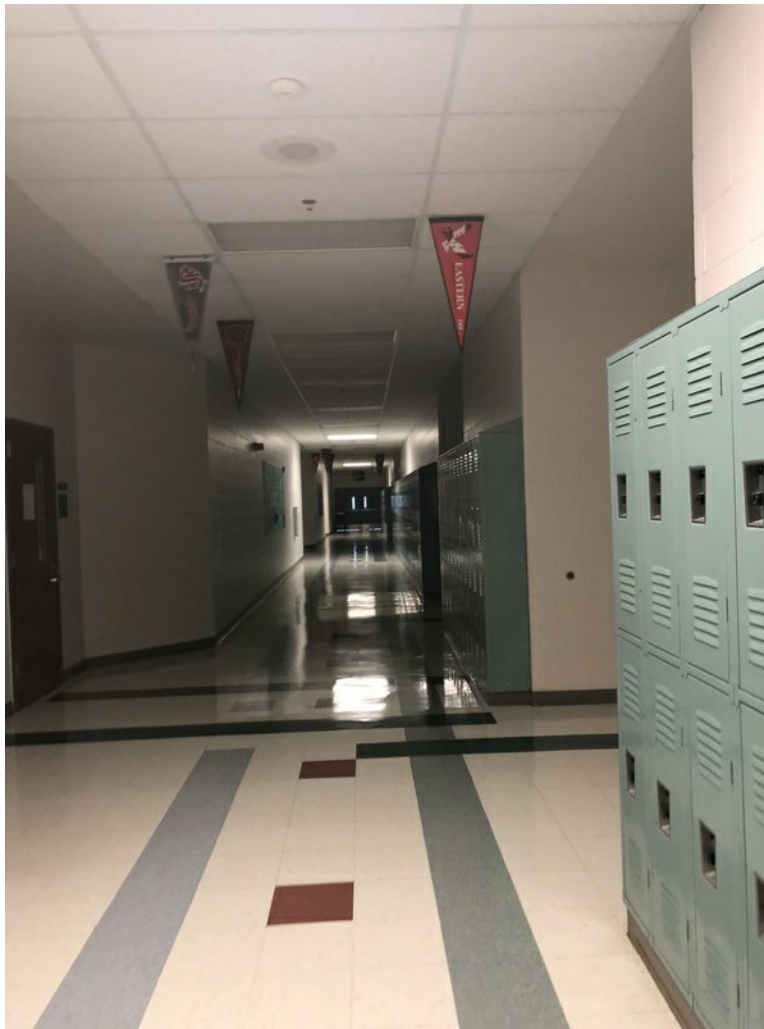
Figure 1-8. Hallway interior.

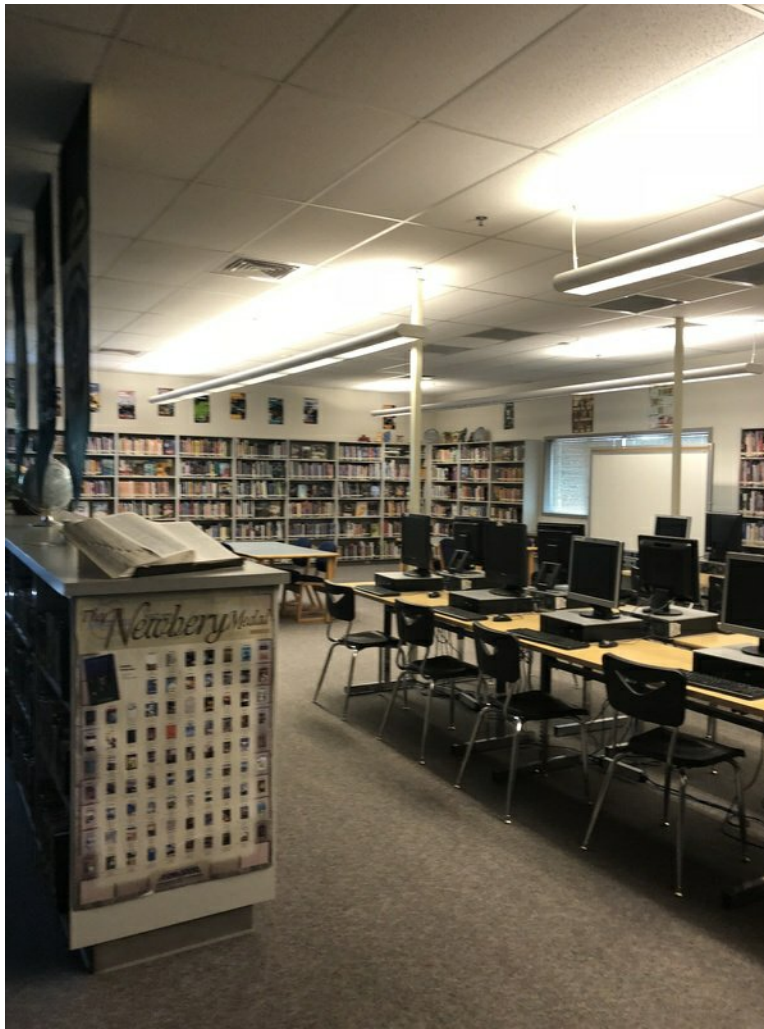
Figure 1-9. Library interior.

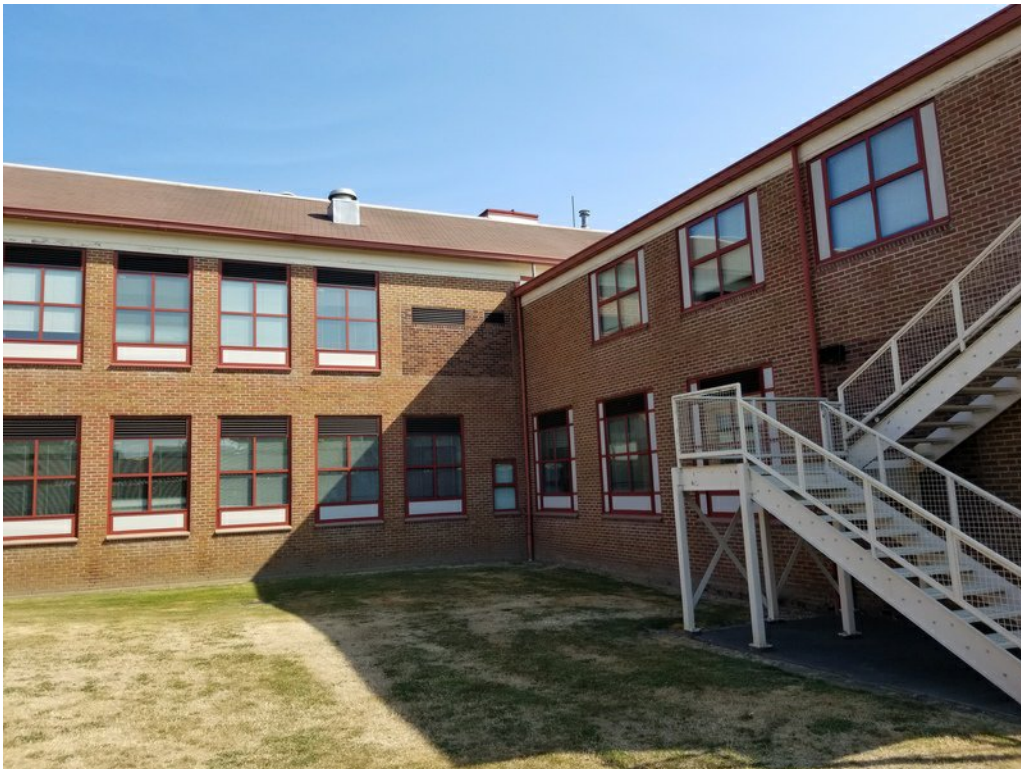
Figure 1-2. Exterior southwest corner of building.

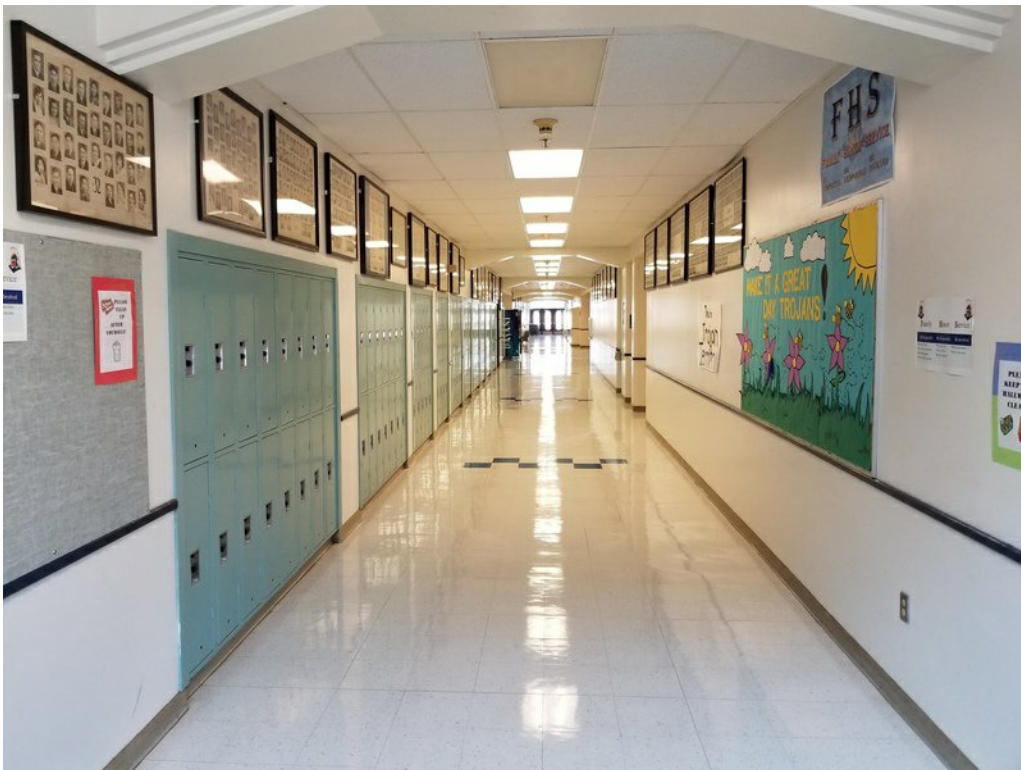
Figure 1-4. Hallway interior.

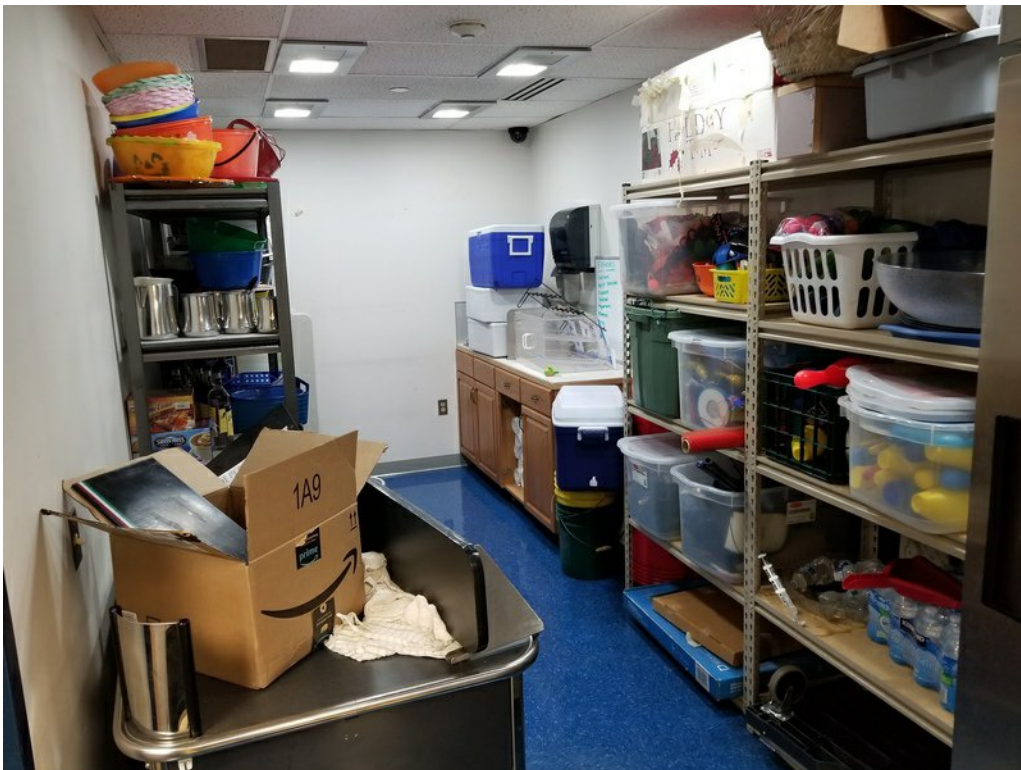
Figure 1-6. Storage room interior with storage racks.

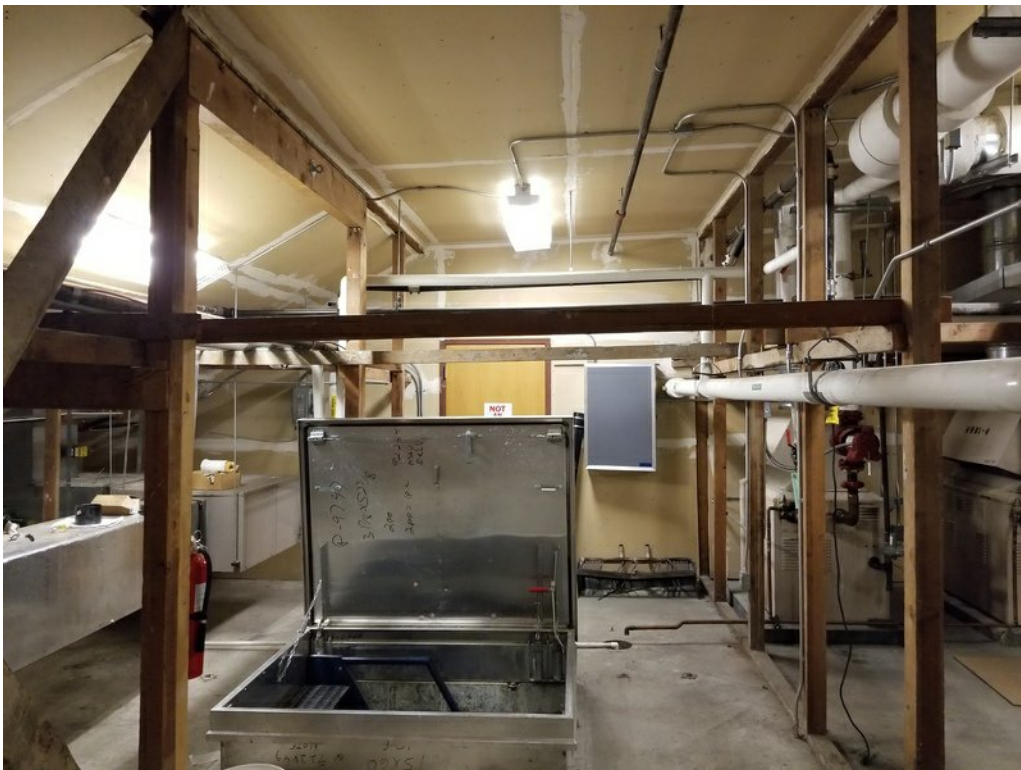
Figure 1-8. Mechanical room interior. Wood frame roof above and 2nd Floor concrete ceiling below.

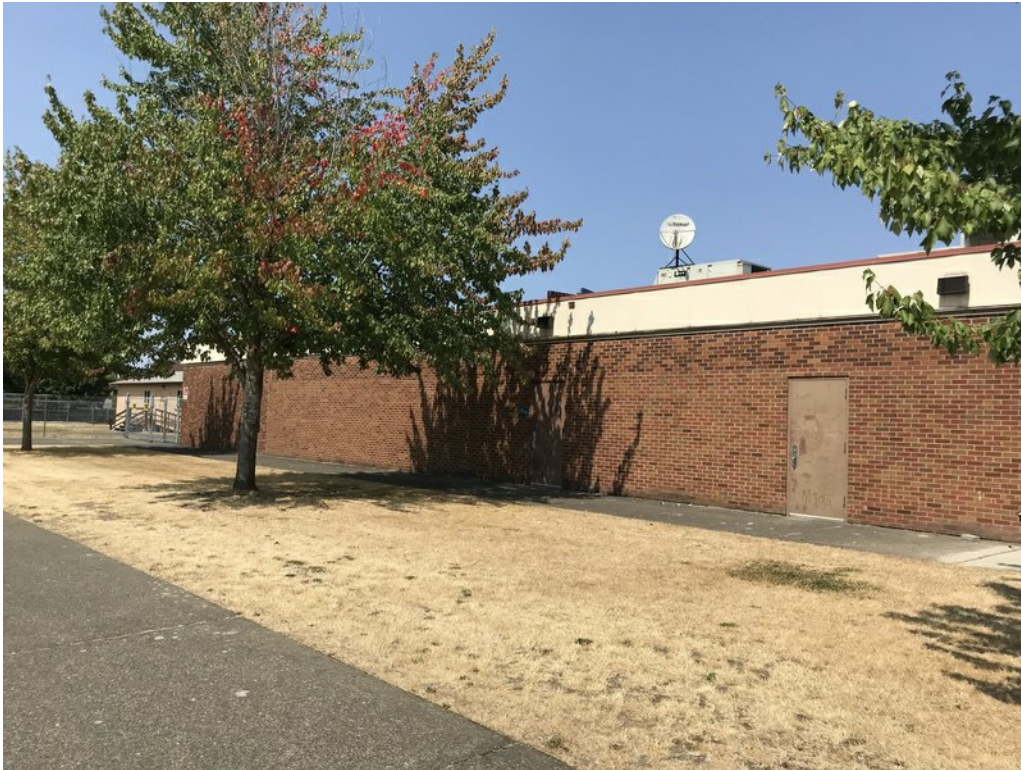
Figure 1-1. Exterior south side of building.

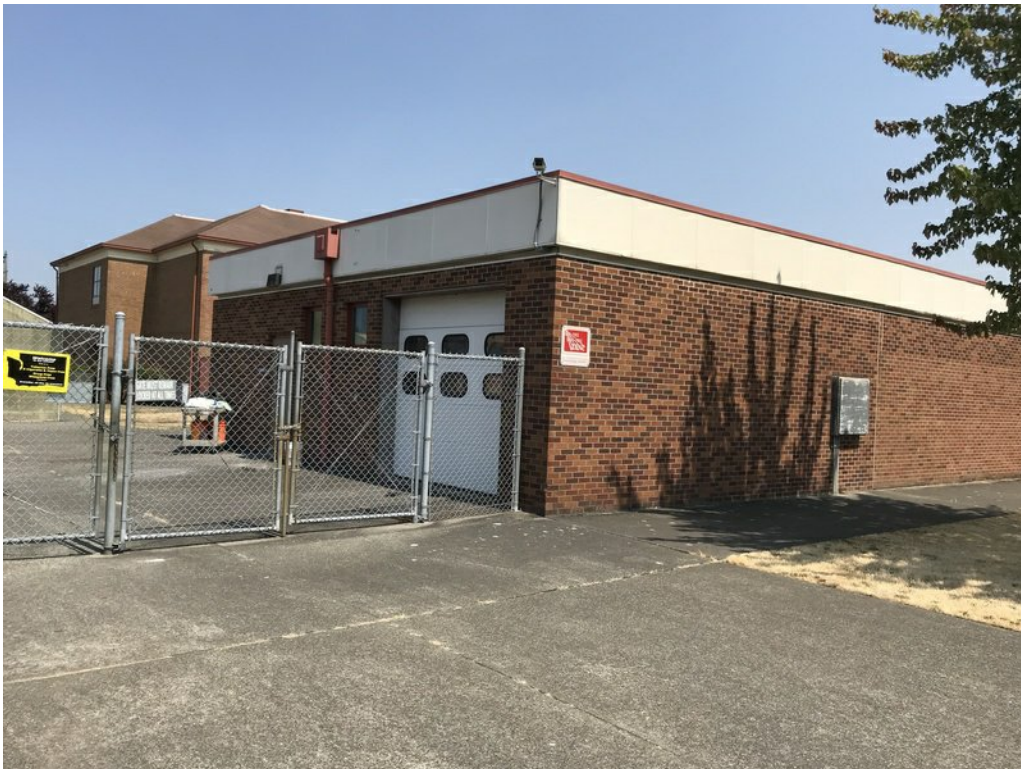
Figure 1-2. Exterior southwest side of building.

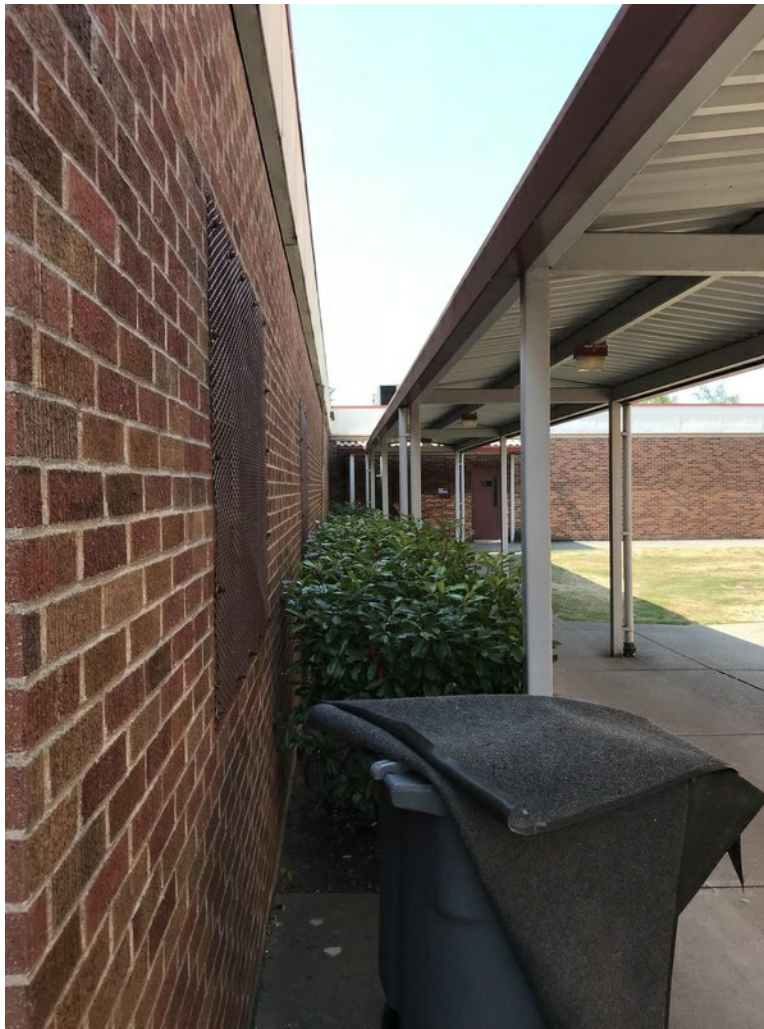
Figure 1-3. Photo from northeast exterior portion of building.

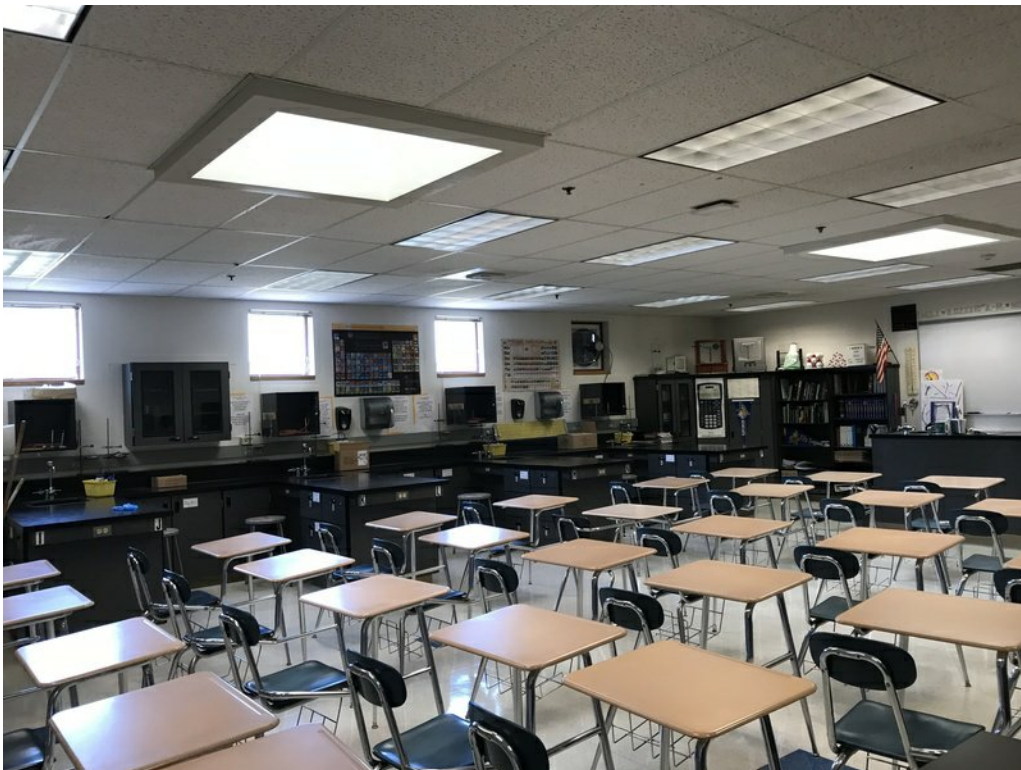
Figure 1-7. Classroom interior on north side of building.

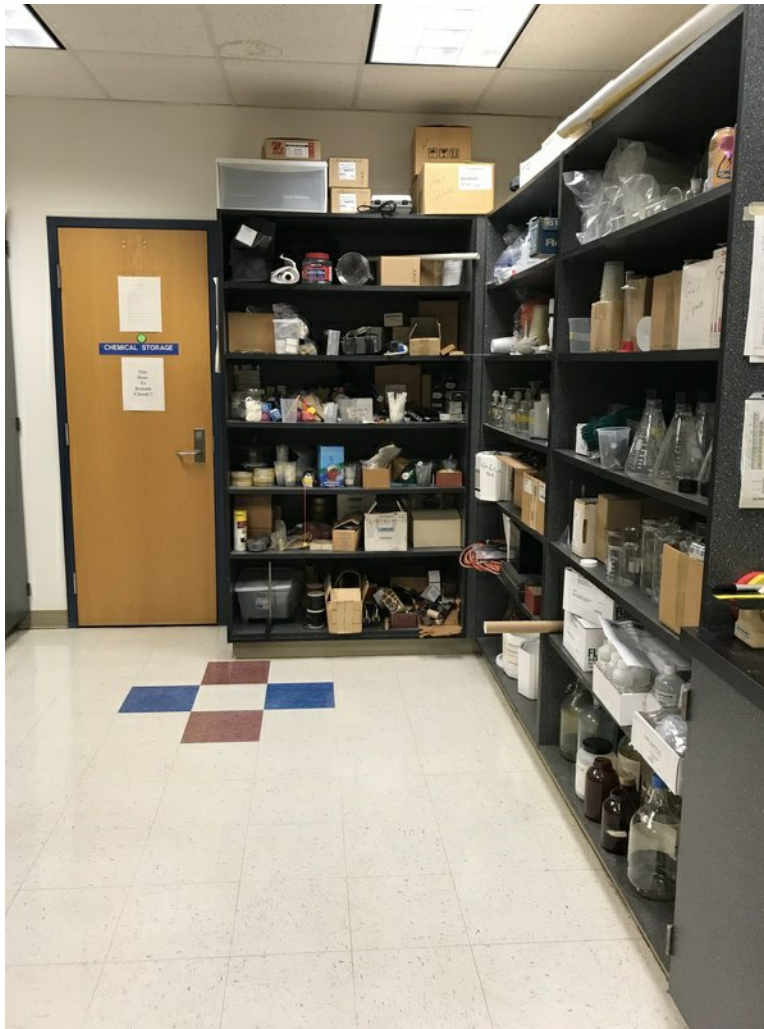
Figure 1-8. Science instruction equipment storage room.

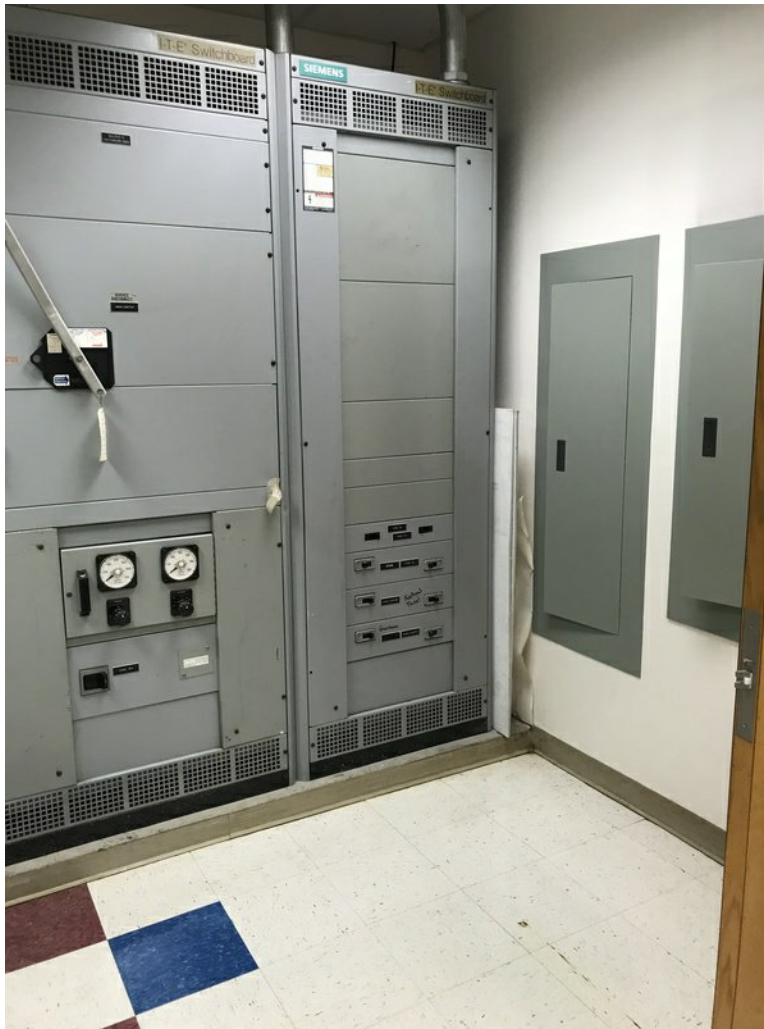
Figure 1-9. Electrical switchboard equipment.

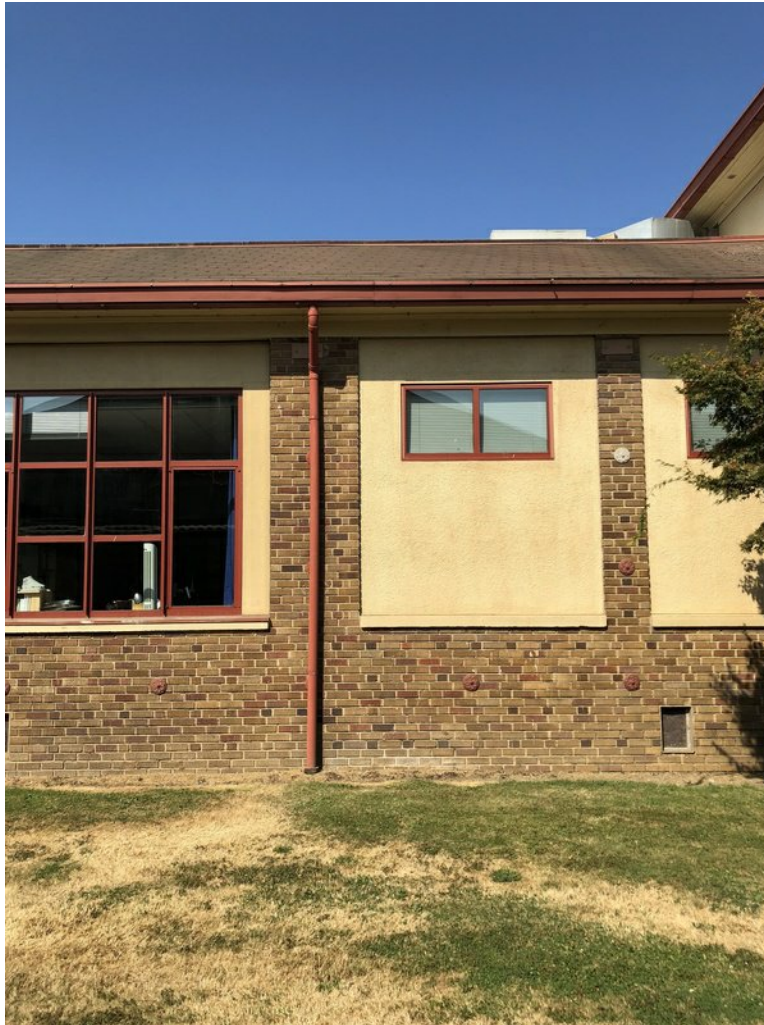
Figure 1-1. Exterior wall with rosette anchors

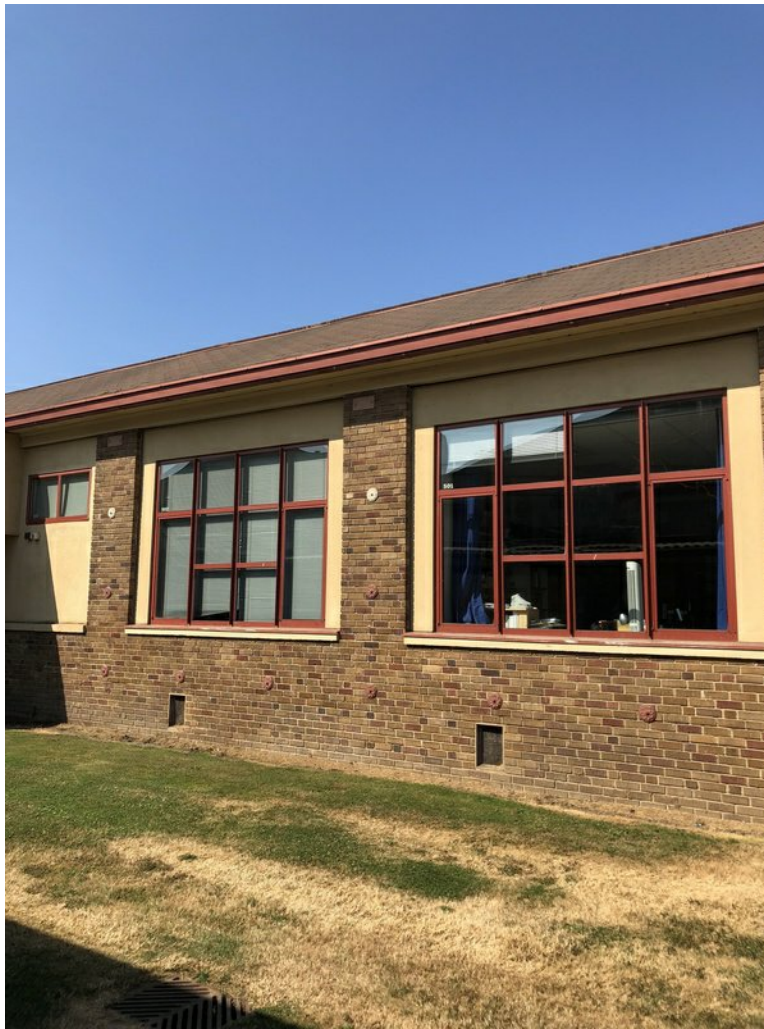
Figure 1-2. Exterior wall with rosette anchors

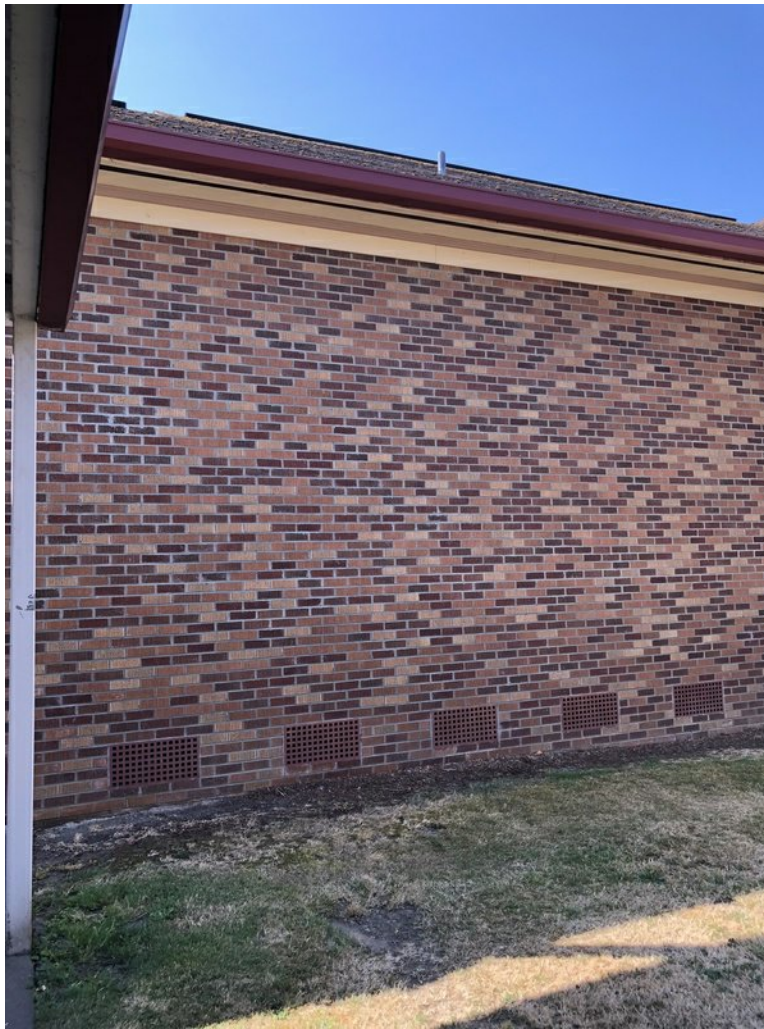
Figure 1-3. Exterior brick veneer of 1992 addition

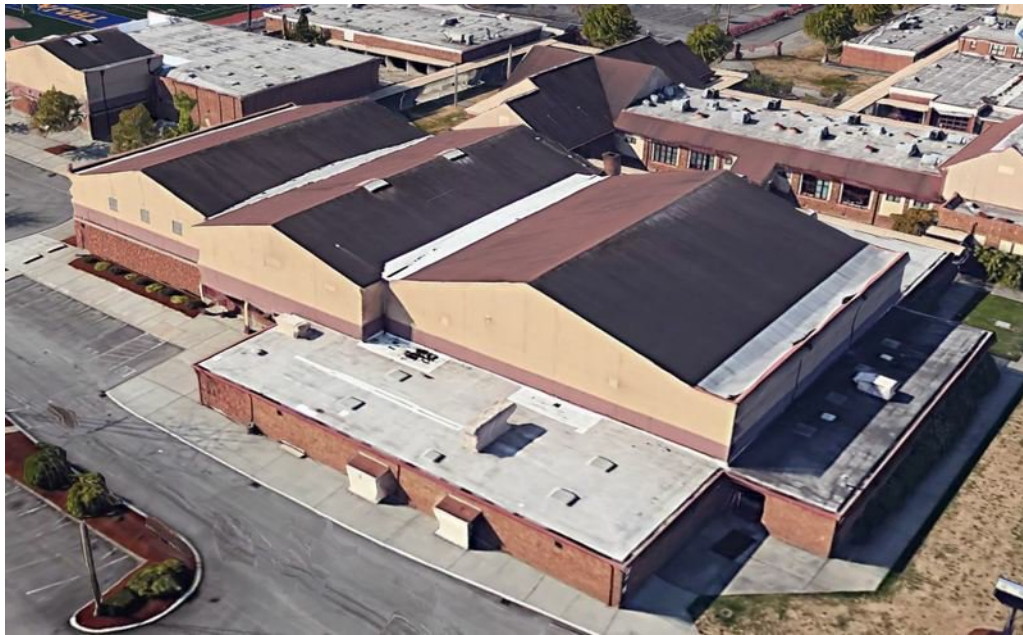
Figure 1-1. Aerial of Bldg 600 looking southwest

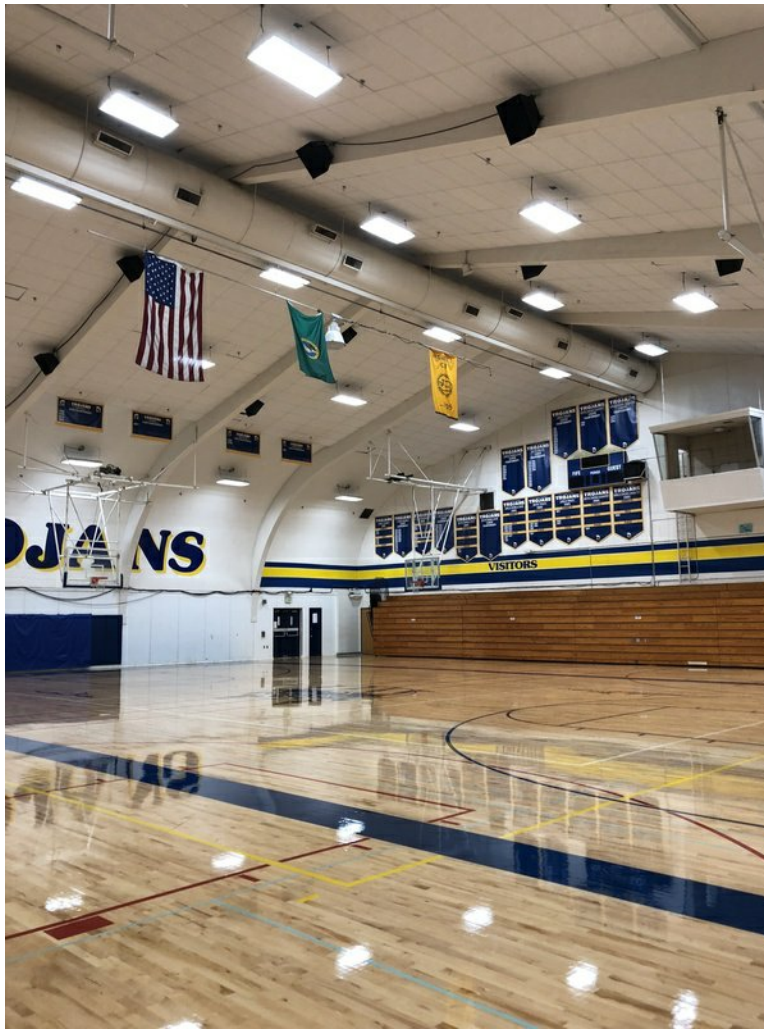
Figure 1-2. Arched glulams of main gym

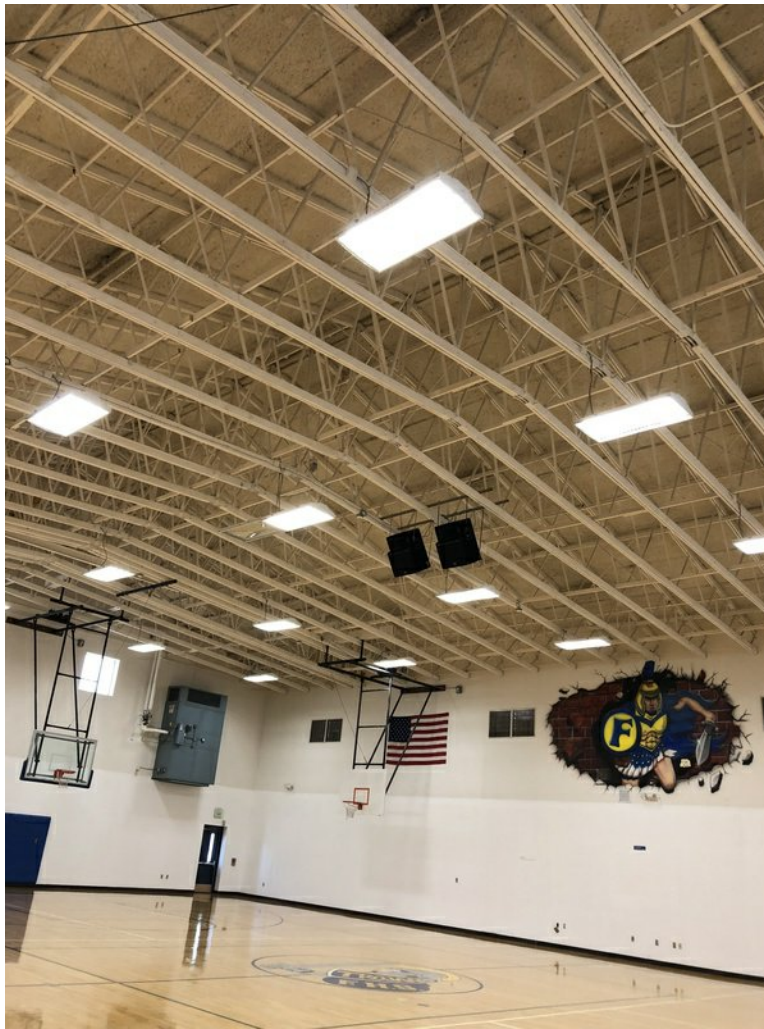
Figure 1-3. Open-web trusses in auxiliary gym

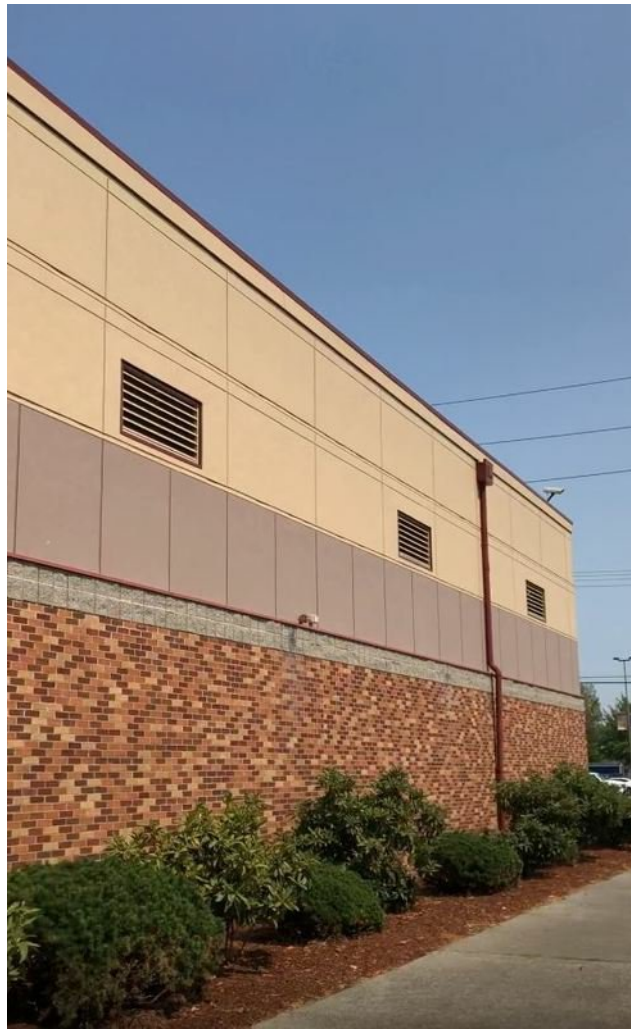
Figure 1-5. South exterior wall with brick veneer and EIFS

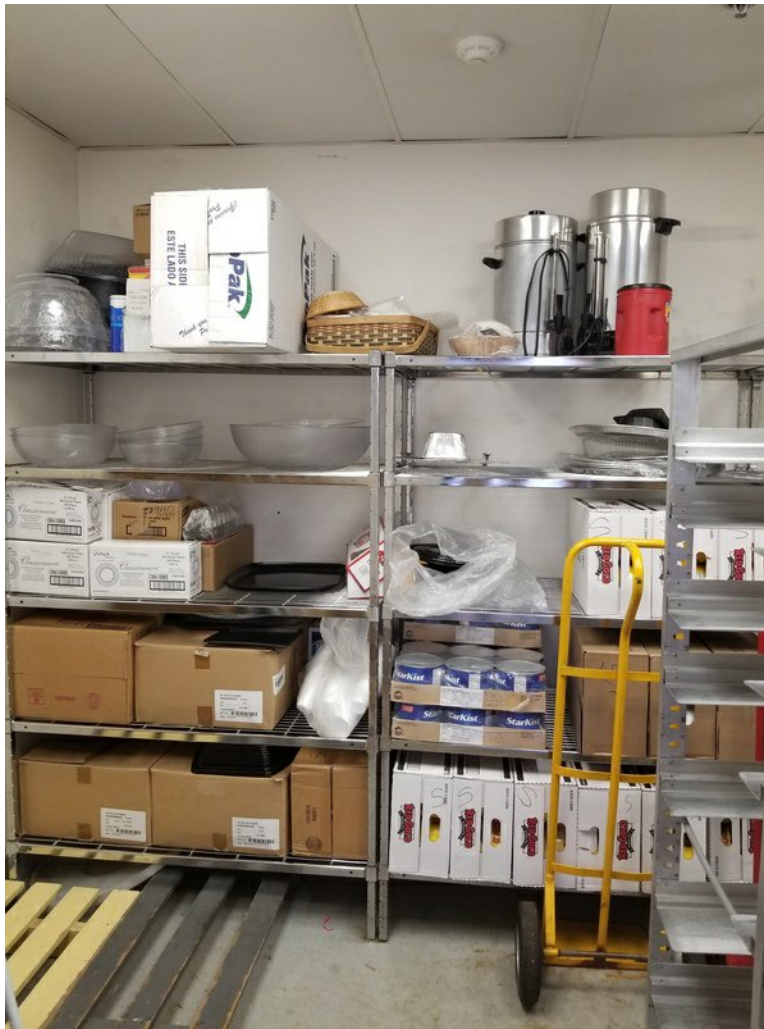
Figure 1-3. Kitchen storage interior.

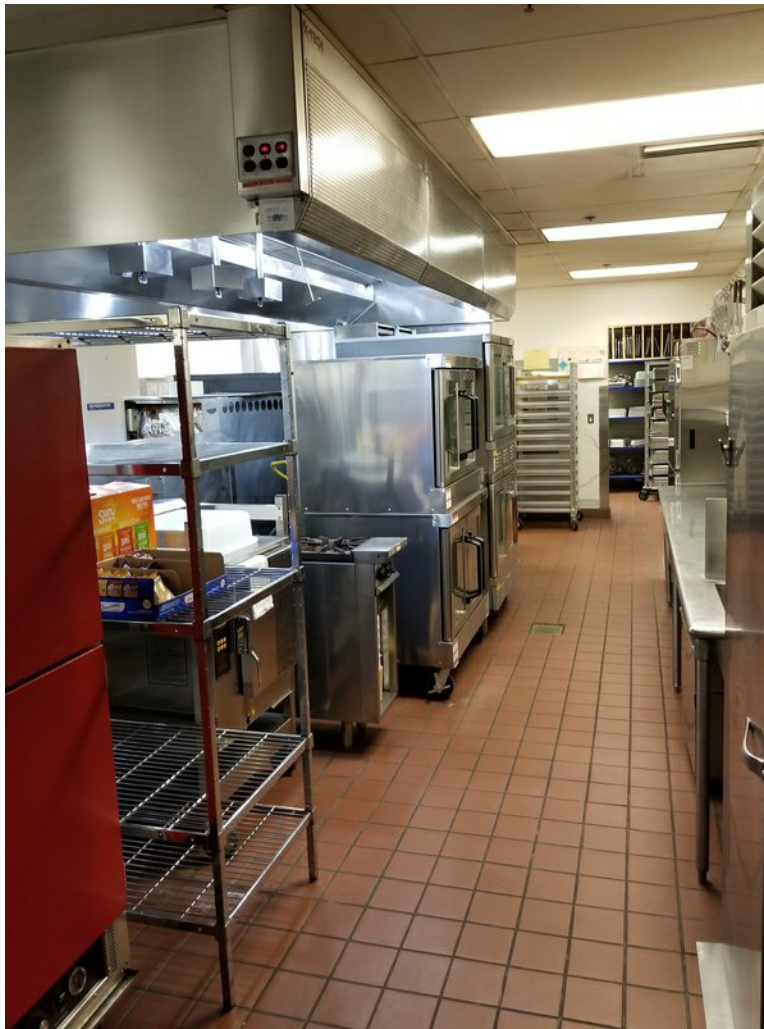
Figure 1-4. Kitchen interior.

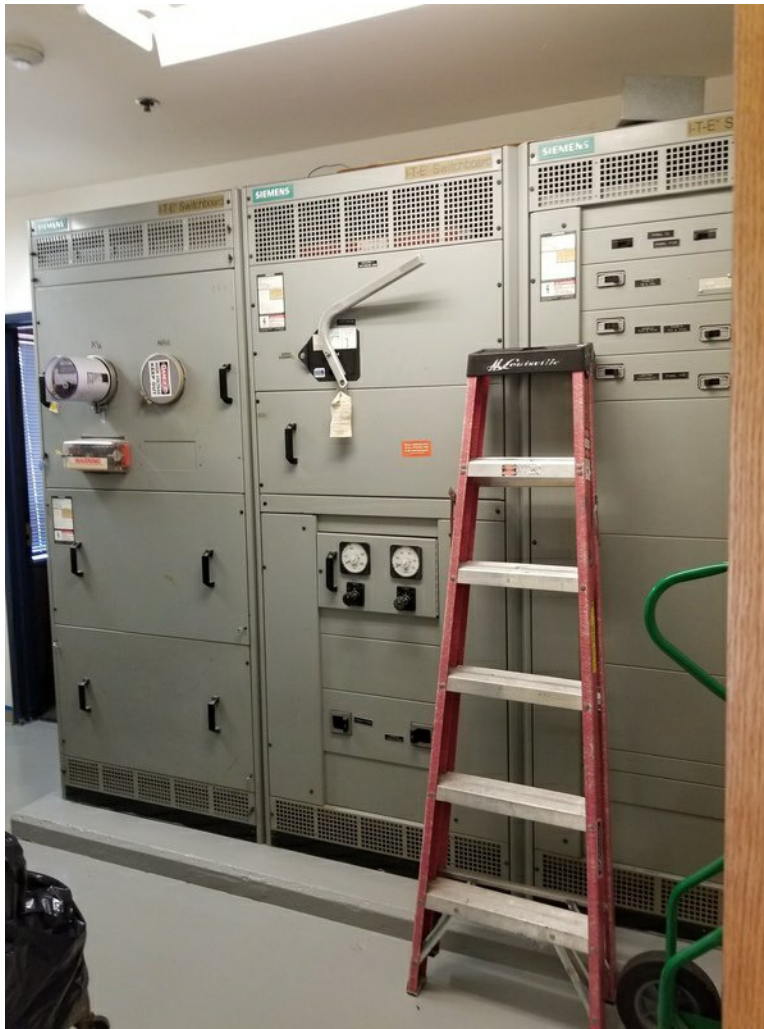
Figure 1-6. Equipment room interior.

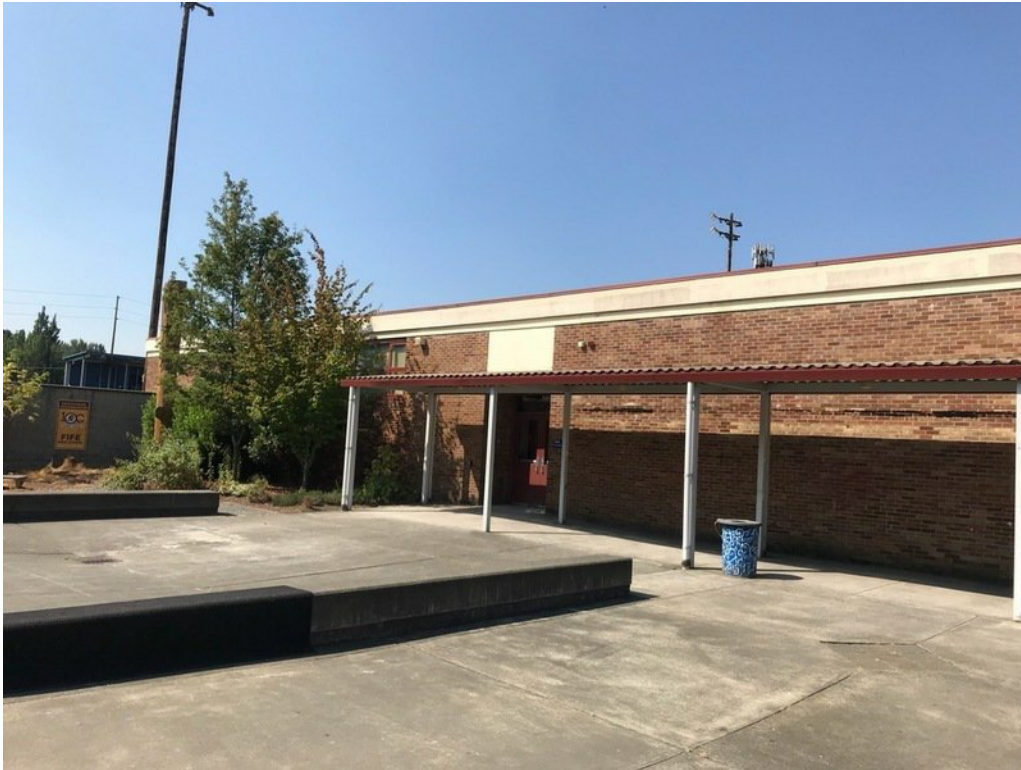
Figure 1-1. Building front exterior.

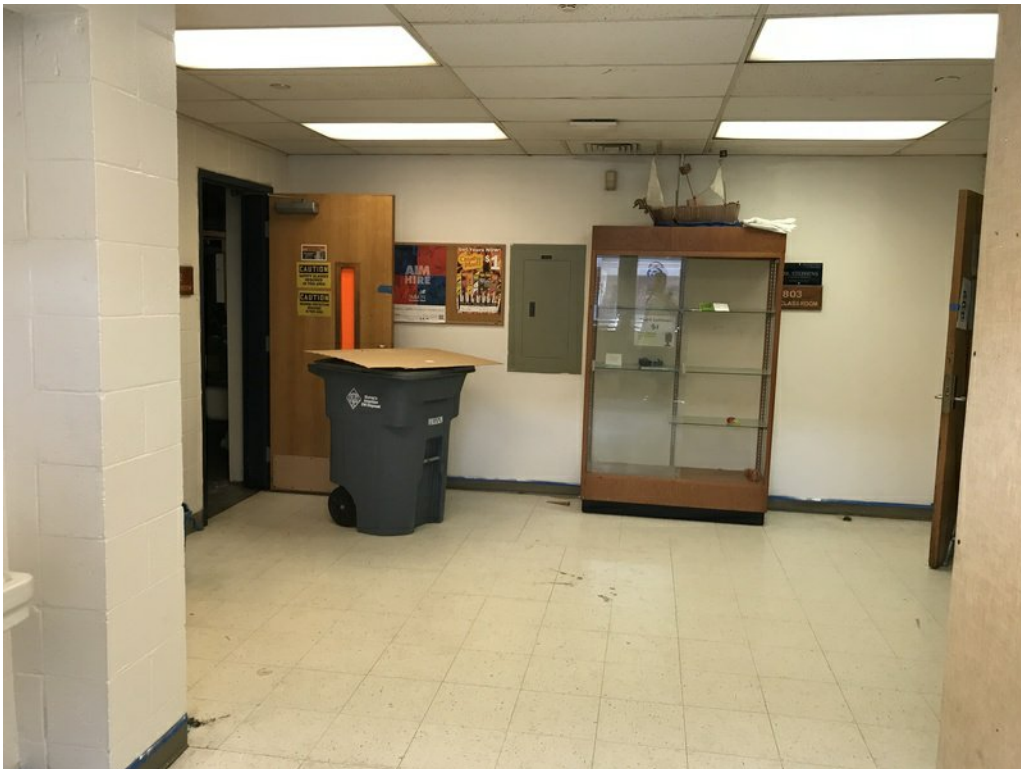
Figure 1-2. Interior entrance foyer showing suspended ceiling and furniture.
